### Inspection Report Minerals Regulatory Program January 31, 2011

<b>Mine Name:</b> Henefer Red Clay	<b>Permit Number:</b> M/043/0014
<b>Operator Name:</b> Interpace Holdings, LLC	<b>Inspection Date:</b> November 03, 2010
<b>Inspector(s):</b> L Heppler	<b>Time:</b> 12:15 pm
<b>Other Participants:</b> Jerry North	<b>Mine Status:</b> Active

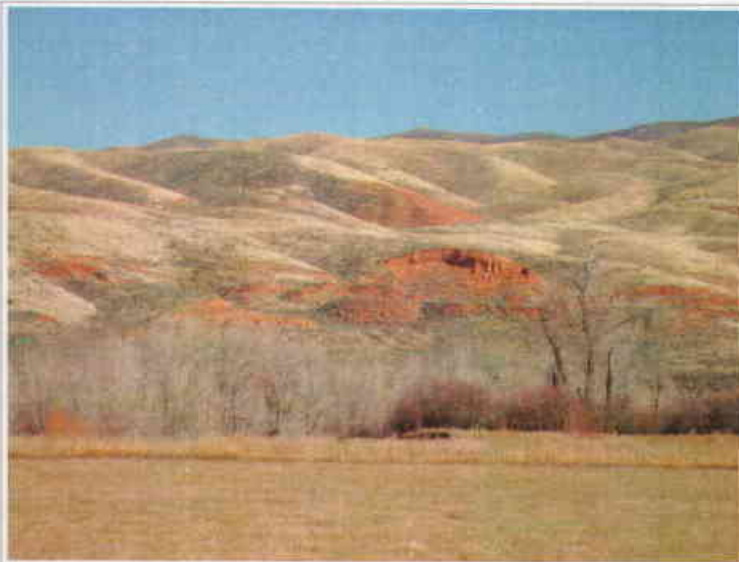
View of regraded site (upper most disturbance) from I-80

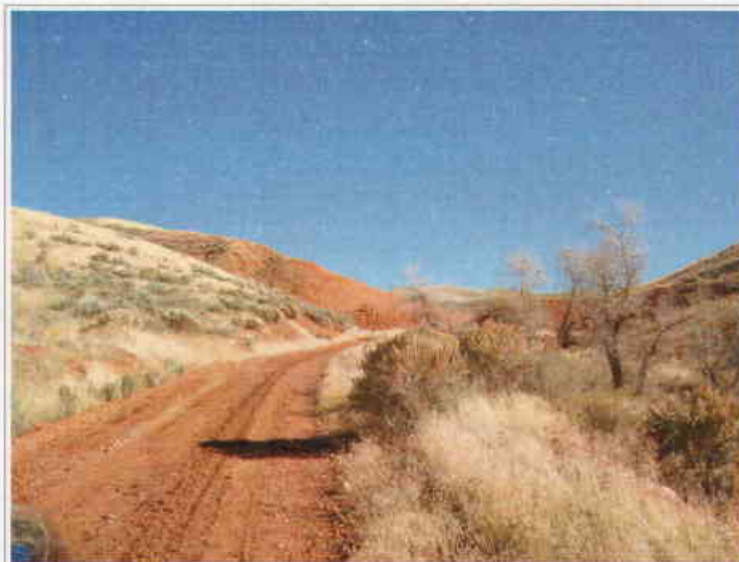
Entrance Road

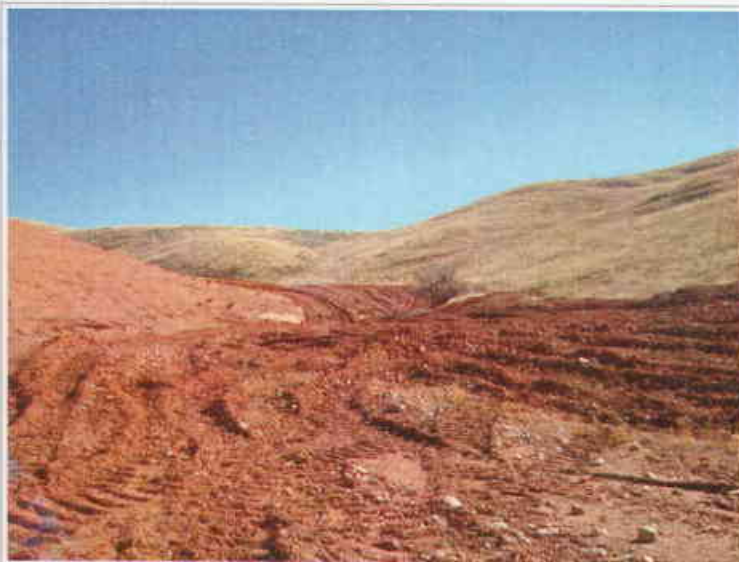
Regraded slope

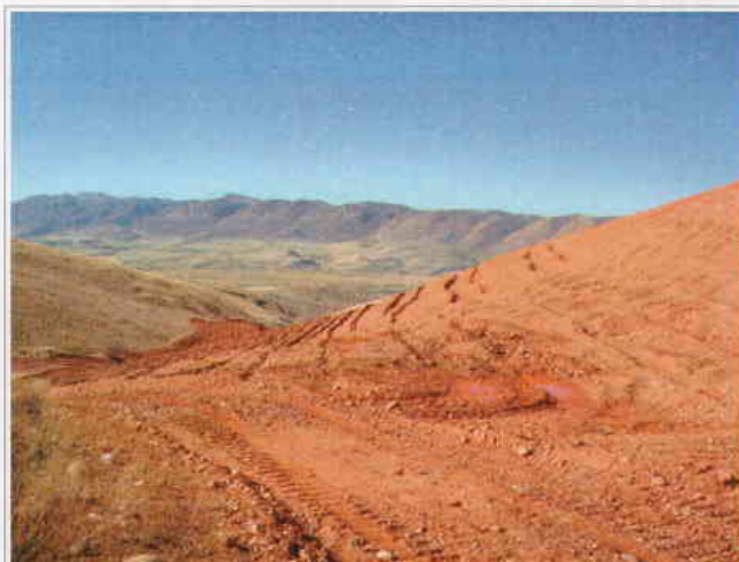
Regraded slope and road to the north access
